**PAWNEE HEALTH CENTER**  
**PAWNEE, OKLAHOMA**

**POST OCCUPANCY EVALUATION**

Office of Environmental Health and Engineering

January 2008

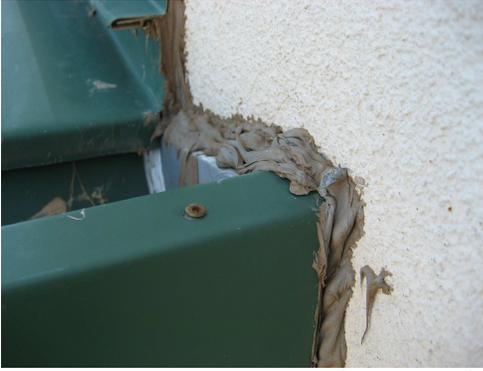
7. The roof/wall flashing has been and is leaking at multiple locations. That flashing was poorly installed and/or the installation poorly coordinated, at:
  - a) several points of intersection of the metal roof and the wall system, and still appears to be a problem despite multiple marginal repair attempts [Picture A-7]; and
  - b) at the vent penetrations along the roof knee wall; and
  - c) at the intersection of the shed skylight and both the wall and the flat roof's membrane system [Picture A-8];

A-7 Roof/Wall Flashing repairs

The flashing in these areas has been problematic despite multiple/on-going repair efforts. Per the drawings (Detail No. 13, Sheet A3.21a) the flashing was the responsibility of the skylight manufacturer, but additionally it is the general contractor's responsibility to ensure installation per the contract documents and to ensure appropriate coordination among all suppliers and subcontractors;

4. Coordination of flashing installation was problematic and/or deficient at:
  - a) the intersection of the metal roof and the wall system (and is still a problem despite multiple repair attempts);

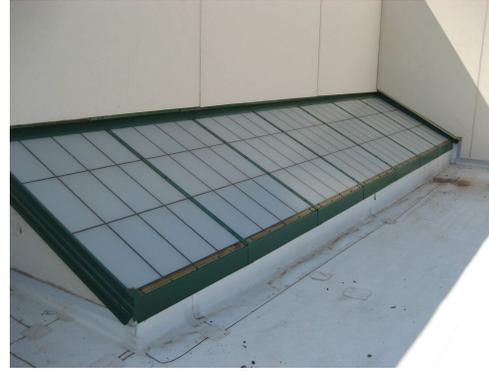
A-8 Skylight/Wall and roof membrane

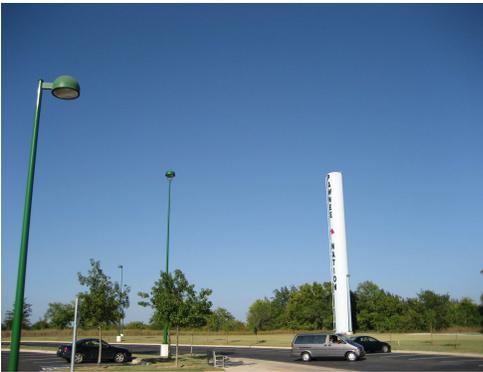
The Service Unit Environmental Engineer reports that the Utility Authority controls the water level in standpipe controlled manually. There are occasions when the tank overflows. At other times the standpipe water elevation may be low enough to affect pressure-assisted flush toilets (need minimum of 20 psi). When low pressure is observed within the health center, facility maintenance staff reports it to the Tribal Utility Authority. The Tribal Utility Authority will then turn on the well pump.

During the evaluation the tank overflow was observed to be actively discharging a full flow.

A-9 Community water storage tank

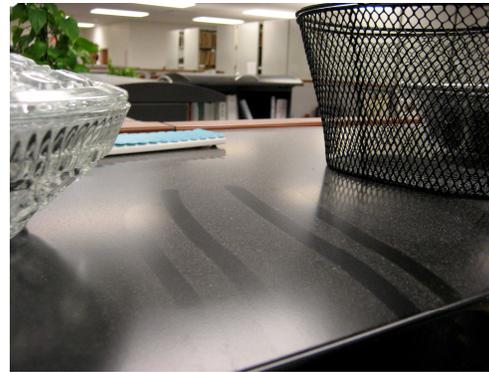
The main building make up (fresh air) supply fan was being repaired during the site visit and had been out of service for several days. With this fan off-line the overall building pressure was significantly negative (ideally it would be slightly positive as a buffer to the infiltration of unconditioned outside air). Without this controlled pathway for conditioned and filtered make up air the building fresh air demand is being drawn from the outside through every available opening; during occupied times primarily through entry doors.

Although active housekeeping throughout the facility is evident, extended periods of unfiltered outside air can overwhelm their efforts and will deposit dust on unexpected surfaces. Substantial dust accumulations were observed on all horizontal surfaces in departments close to the main entry [Picture A-10].

A-10 Dust accumulation

This single make up fan is critical to controlling building pressure and dust. Consider maintaining a more comprehensive spare part inventory for this fan unit and perform maintenance on the unit after normal hours with other fans off to minimize infiltration.

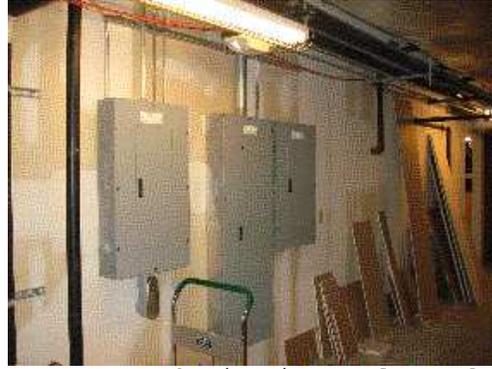
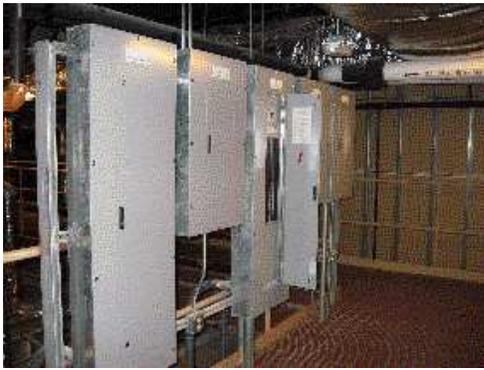
All branch circuit panel boards were found lacking TVSS protection [Pictures E-2 & E-3]. The circuit breaker schedules of a few panel boards in the attic were found to be non-corresponding to their respective as-built circuits.

All branch circuit panel boards were found to be non-compliant with OSHA, NEC, and NFPA 70E codes with regard to arc flash protection for O&M staff. Records or tests that show phase to phase voltage balancing in each of the branch circuit panel boards were not found.

E-2 Branch Circuit Panel Boards

E-3 Branch Circuit Panel Board

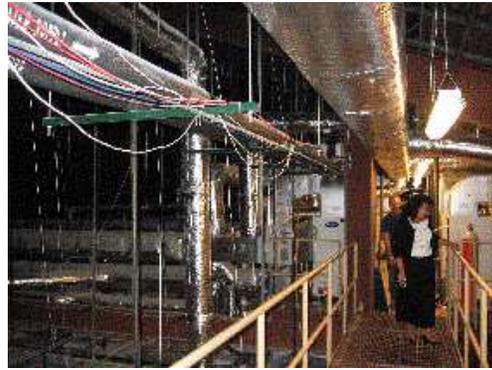
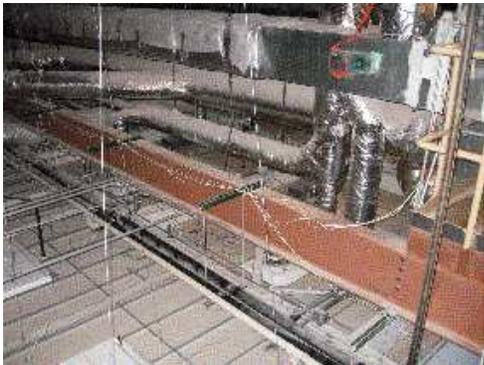
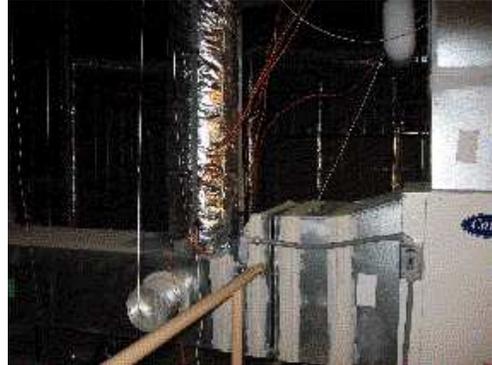
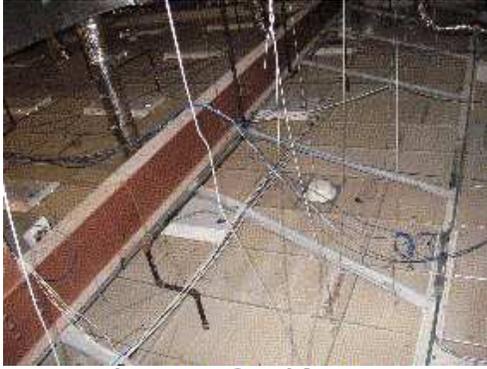
Throughout the building attic it was found that the existing raceway infrastructure is insufficient for the proper installation of current and future low voltage cables for the following systems: telephone and data, fire alarm and HVAC controls [Pictures E-4, E-5, E-6 & E-7]. NEC requirements do not allow the supporting of cables for the aforementioned systems on ceiling tiles. This code also limits the means for routing conductors that are not properly placed in a conduit or cable tray.

Telephone services cabling has been accomplished using CAT 5e UTP cable; however due to the absence of adequate cable trays along the ceilings of building corridors, the telephone cable installation was found completely untidy. In the attic, lots of CAT 5e white cables have been installed on ceiling tiles and also supported by building structure and equipment. Installers did not follow directions from Contract specification 16191.C.

E-4 Absence of Cable Tray

E-5 Absence of Cable Tray

E-6 Absence of Cable Tray

E-7 Absence of Cable Tray

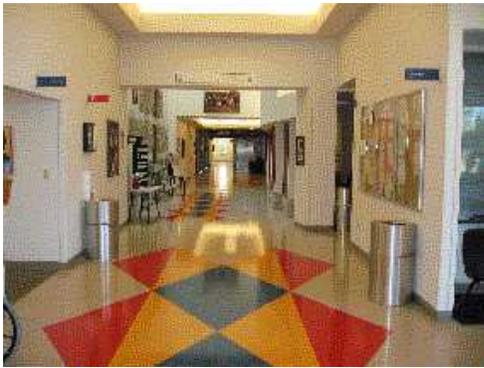
Lighting of all the HCC interior spaces allocated to halls, offices and rooms for patients was found to be adequate [Picture E-9]. However, there is excessive dust accumulated in the attic [Picture E-10]. This dust filters down and also accumulates on the surface of fluorescent lamps and on the surface of each of the diffusers of light fixtures installed below the false ceiling. Dirty lamps and light fixture diffusers decrease the level of illumination designed for the HCC. Dust particles that filter from the HCC attic may also contribute to the creation of indoor air quality problems.

E-9 Interior Lighting

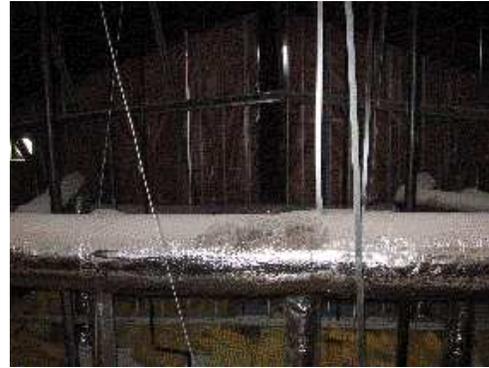
E-10 Excessive Dust Accumulation in Attic

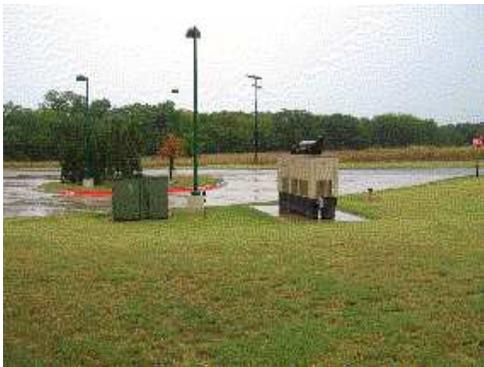
However, no documentation was found regarding engineering calculations or the criteria applied to show that the rating of the existing generator matches or exceeds the total load of the essential emergency electrical system of the new HCC. This is a requirement of NFPA 99, 4.4.1.1.9

The Pawnee HHC emergency generator is located outside of the building approximately 30 feet from the north corner of the building. Picture E-11, shows that the generator is closed to an outdoor light; however, per NFPA 99, it should have a permanent task light over the top of the generator, and this light would be lit by the generator when a utility power failure occurs. Also, per NFPA 99, at least one outdoor power receptacle powered by the generator should be installed near the generator.

E-11 Emergency Generator

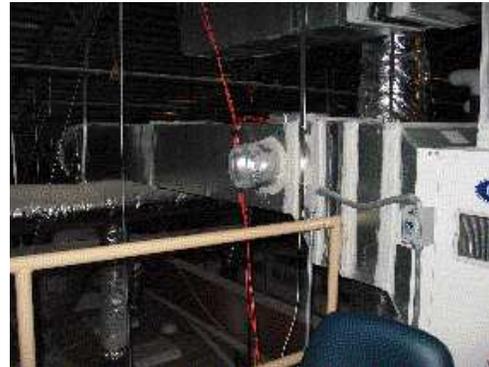
Fire Alarm control cables were found not installed per NEC [Picture E-12].

E-12 Fire Alarm Control Cables not installed per NEC

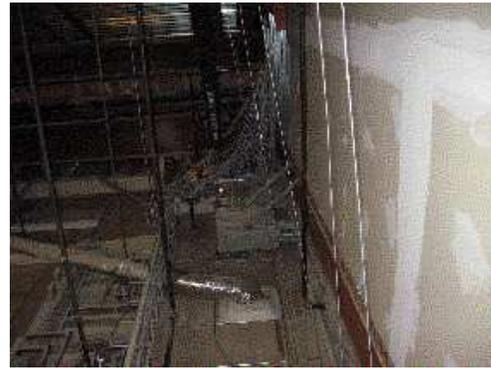
The fiber optics cable was found installed without inner duct, and due to the absence of adequate cable trays along the ceilings of building corridors, the LAN cable installation was found completely untidy. In the attic, lots of CAT 6 blue cables have been installed on ceiling tiles and also supported by building structure and equipment [Picture E-16].

E-16 Attic, Cable Entrance to ITS Rack at ITS Racks
