INDIAN HEALTH SERVICE HOSPITAL
BROWNING, MONTANA
FACILITY POST OCCUPANCY EVALUATION

DIVISION OF HEALTH FACILITIES PLANNING
OFFICE OF RESOURCE MANAGEMENT
OFFICE OF MANAGEMENT
OFFICE OF THE ASSISTANT SECRETARY FOR HEALTH

SEPTEMBER, 1990

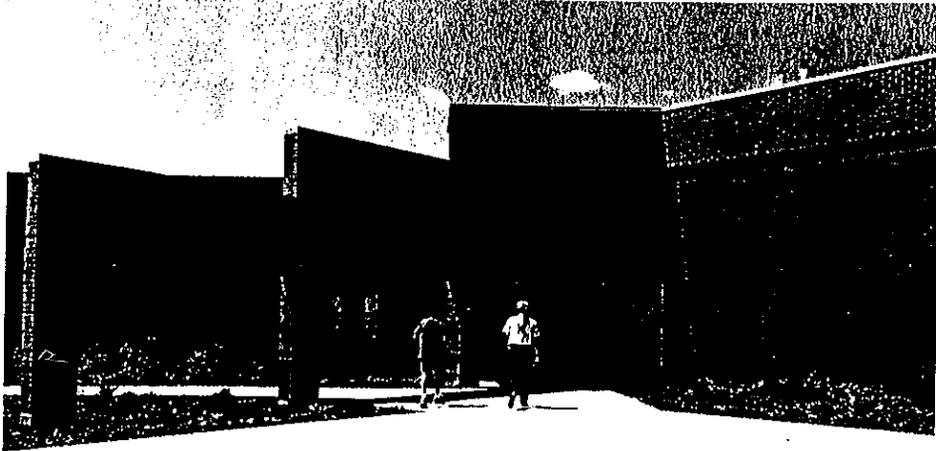
- f. Signage/Identification: The new building is not well identified for the first-time visitor. At the entrance to the BIA/IHS compound, there is one directional sign, which reads "hospital". At the approach to the building there is no sign giving directions to the main entrance, which is actually near the rear of the complex. One could assume that the entrance to the original building, now used for tribal health programs, is the hospital entrance. Once around the east side of the complex and past the fenced vehicle storage area, the only sign, other than parking signage, is mounted on the wall at the front entrance. It reads "Blackfeet Community Hospital." There is no reference to the IHS or PHS (see photo 3).

3. Main entrance, showing sole building identification sign at right of entrance doors.

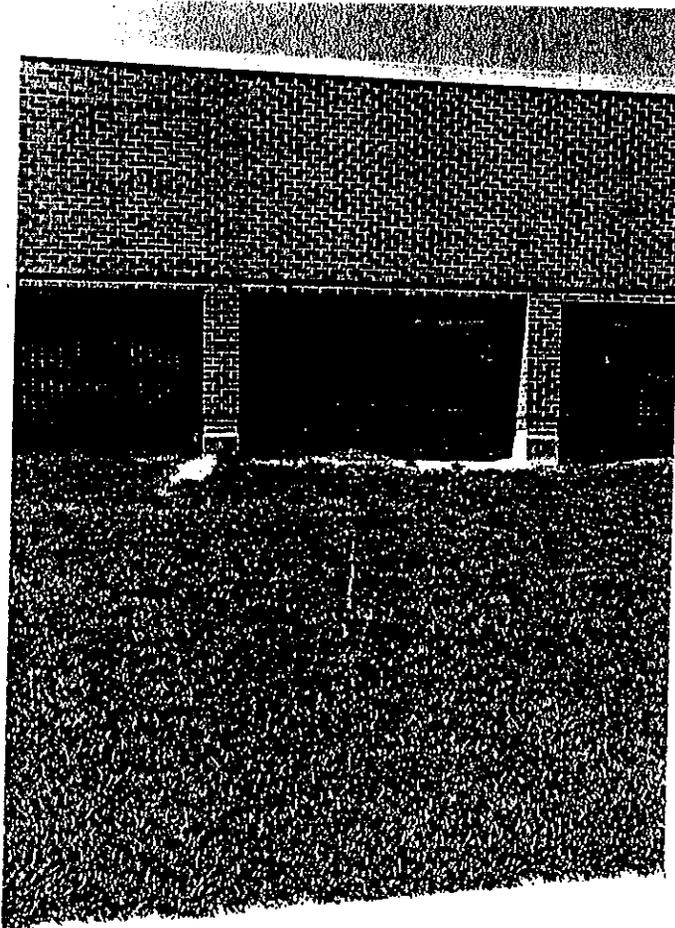
4. South wall of acute care wing, showing ground bermed up to window sill height. Windows are located in recessed areas under "parapet" wall.

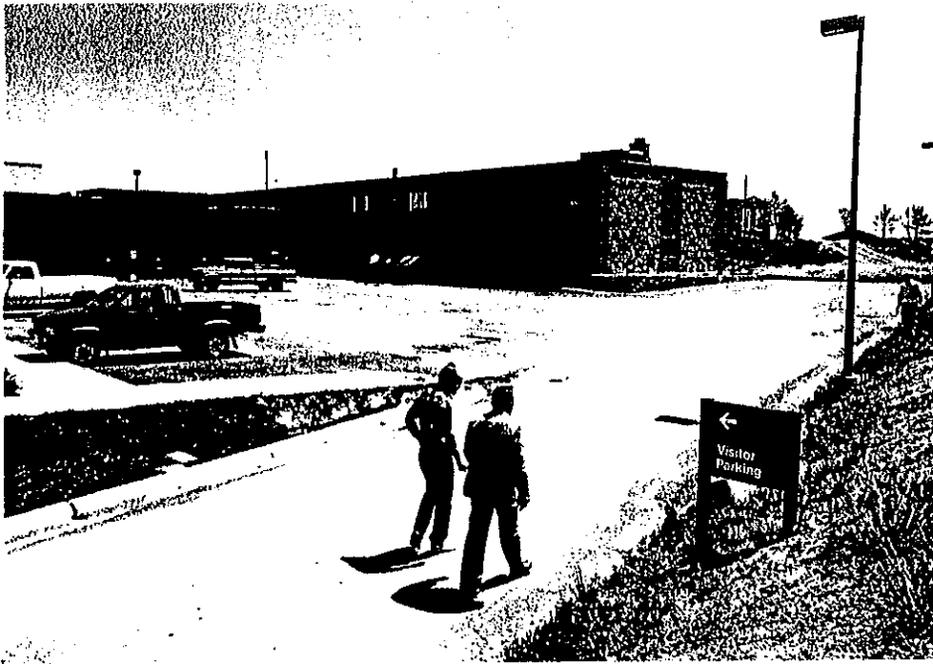
- d. The loading dock and service entrance are unfavorably located on the windward side of the building (see photos 5 and 34). Browning is subject to strong winds during much of the year, and the configuration of the dock and service entrance in a pocket cause this area to collect windblown dust, snow and trash.

5. Acute care visitor parking, service entrance, loading dock and renovated 1960 wing.

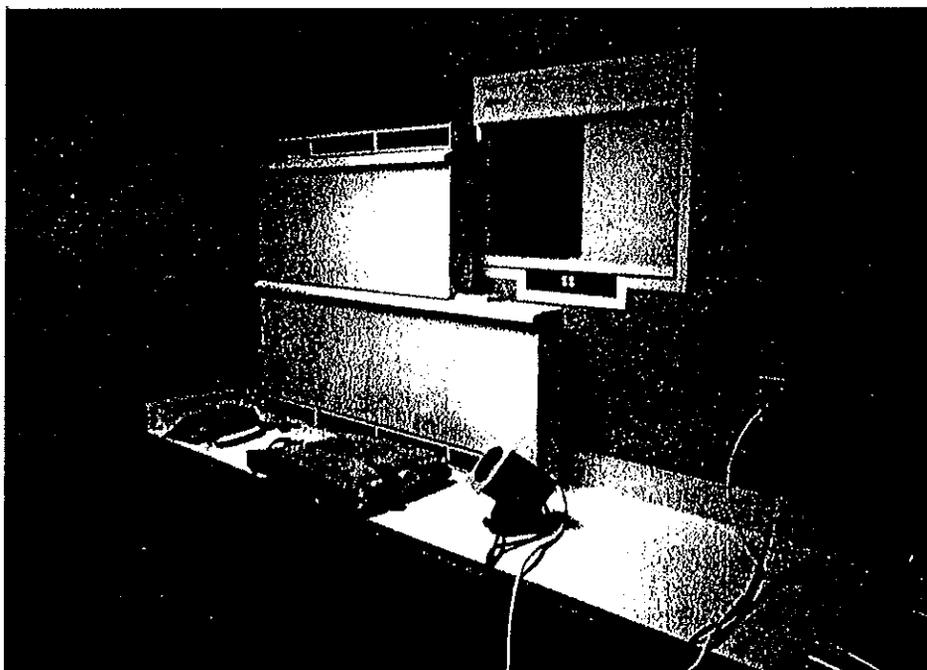
14. Radiology film viewing room, with portable film illuminators added to supplement built-in unit.

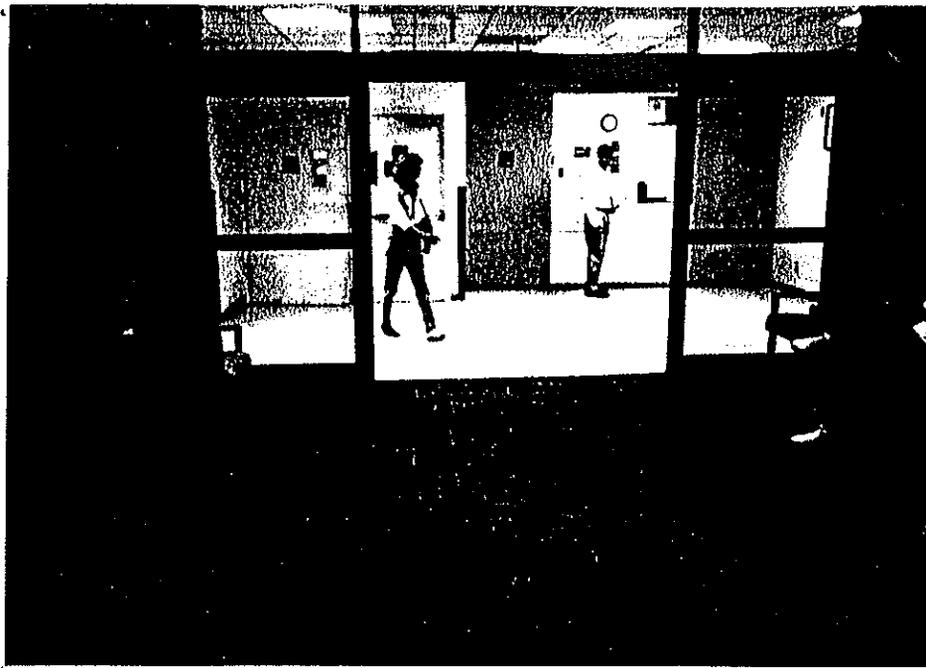
- 2) The area designated for emergency waiting is little more than a widened corridor in front of the reception window. It is used for waiting only in cold weather, when it is very inadequate in size (see photos 15 and 16).

15. Emergency entrance with vestibule in foreground (dark area), waiting area and reception counter beyond.

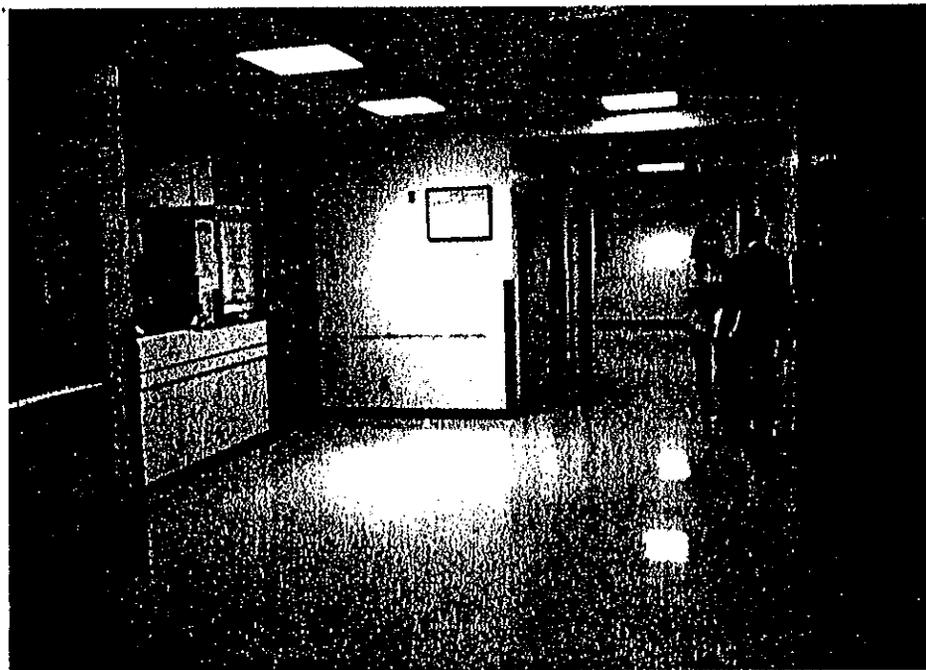
16. Emergency care corridor with small waiting area and reception counter at left. Note marks on waiting area wall caused by chairs located here during cold weather.

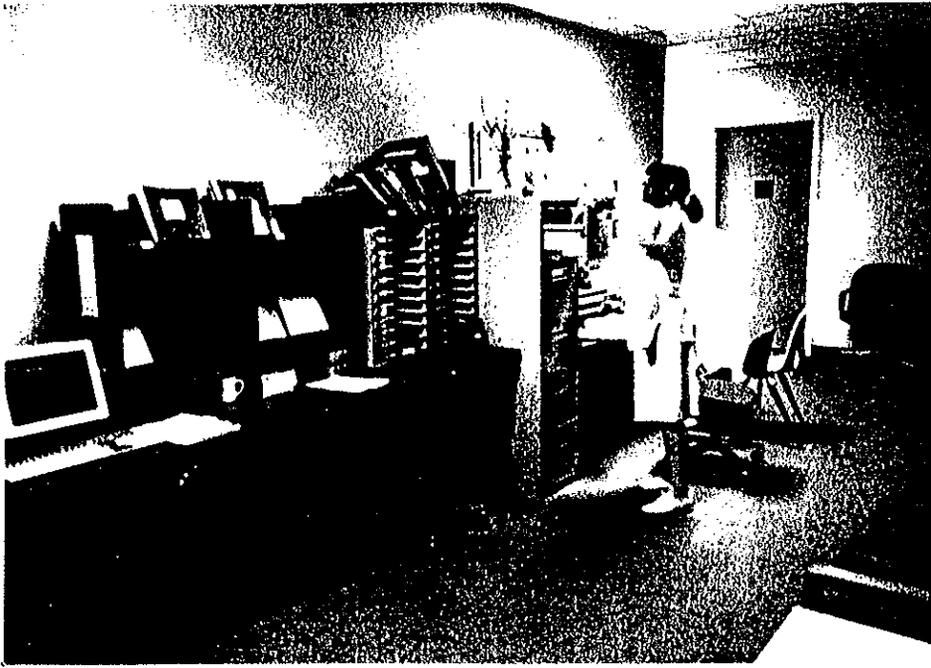
- 1) The original nurses station, control and charting area, which faces the main waiting room, was found to be too remote and too small, and is now used by the receptionist and clerks. Half of the sub-waiting area behind the department entrance doors has been converted to a nurses work and charting area. This shift has resulted in a less-than-ideal arrangement for the nurses work area, and also too little space available for patient sub-waiting (see photo 17).

17. Ambulatory care sub-waiting area which has been converted to nurses work and charting area.

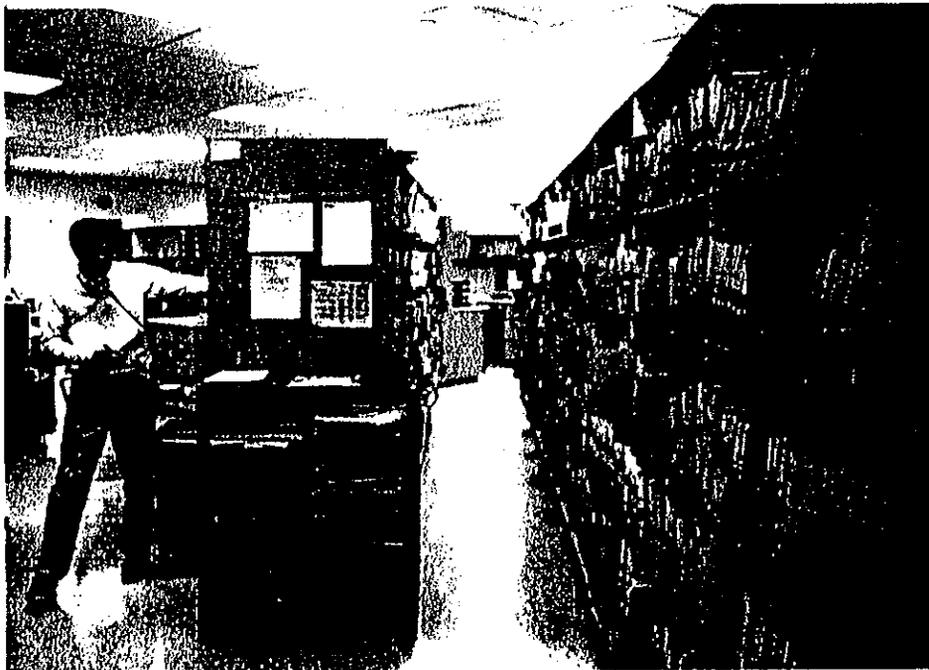
- d. Much of the built-in and movable shelving is sagging. This is due to the use of particle-board shelving in heavy loading situations (such as medical records, radiological films and pharmacy supplies). Such flexible

20. Medical records active record storage area, with typical plastic laminate shelving which has been stiffened to correct excessive sagging.

shelving materials should not be specified in these situations.

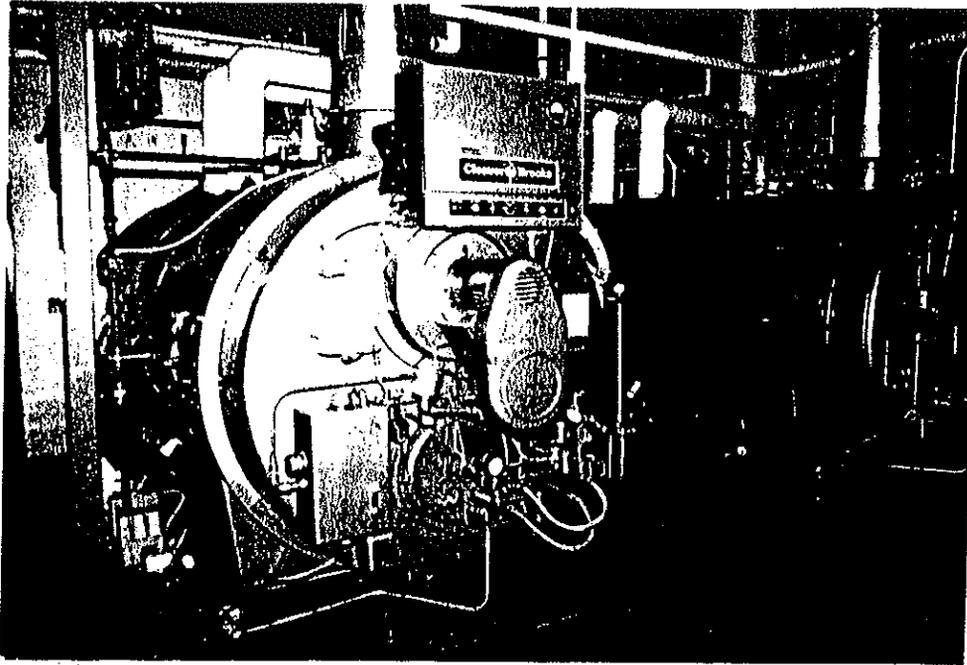
25 Hot water heating boiler, dual fueled natural gas and fuel oil. Note lack of pipe hangers over boilers.

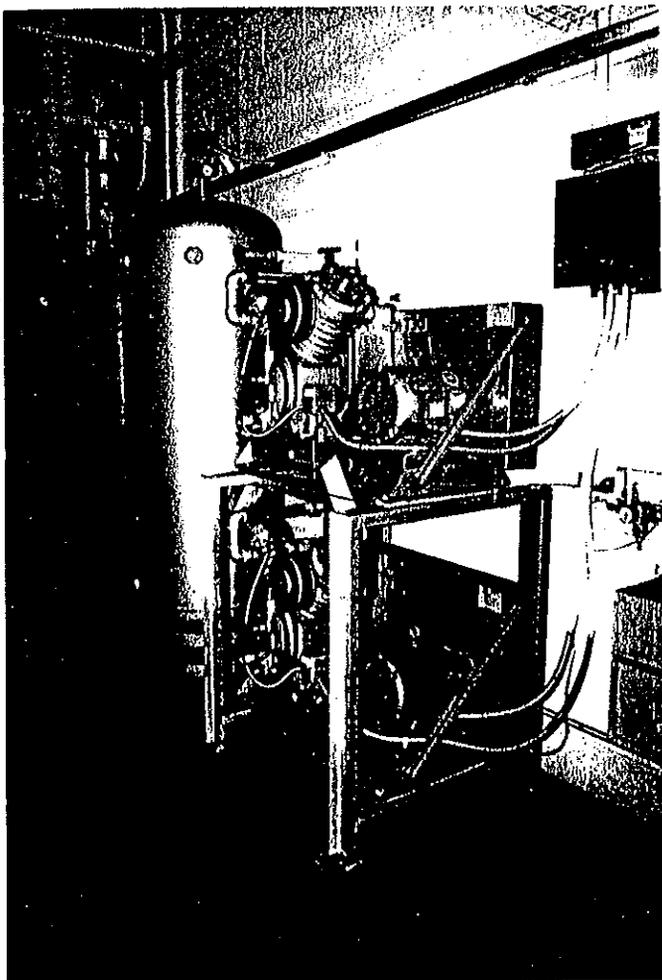
28 Duplexed control air compressors
compressors with air storage tank
and expansion tanks for heating
water system behind. Note lack
of housekeeping pads.

All mechanical equipment should be elevated above the floor for cleanliness and long life.

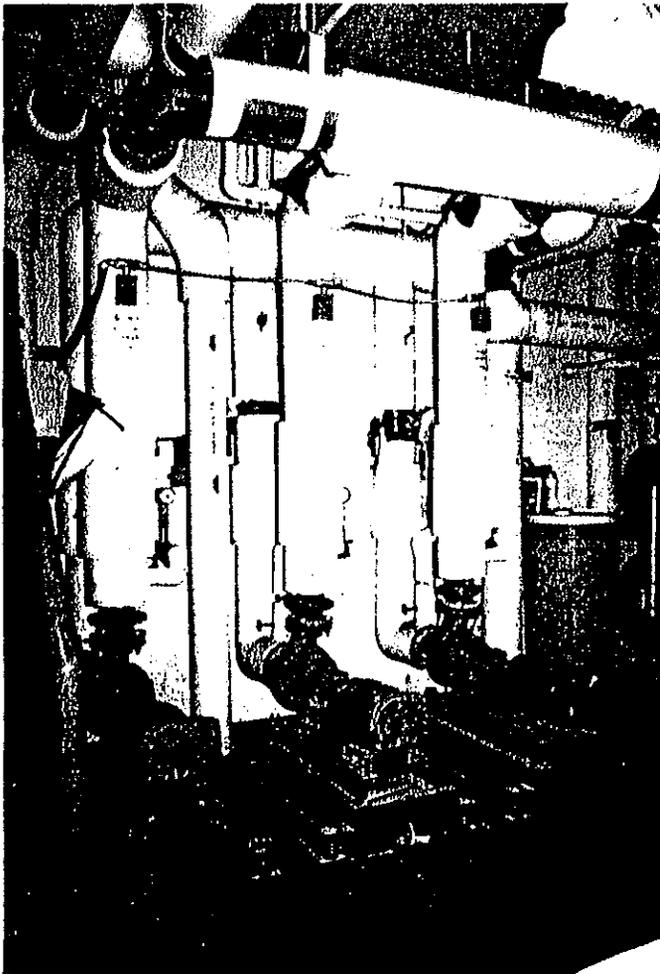
30 Hot water heating pumps. Note
new butterfly valves ready for
installation and lack of pipe
supports

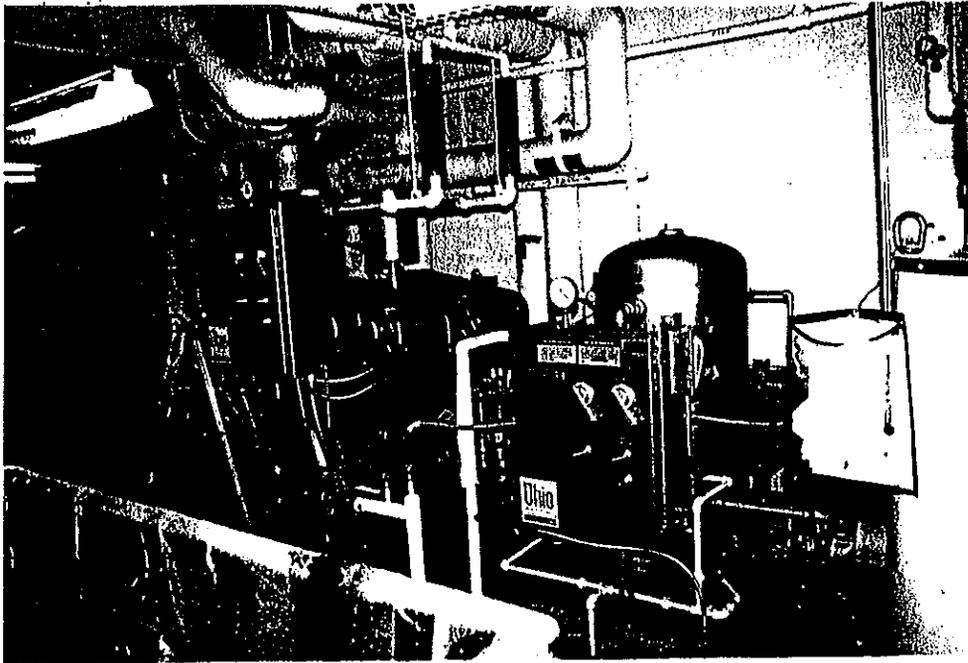
31 Medical duplex air compressors and vacuum pumps with storage tanks. Note plastic to catch drips from valves above.

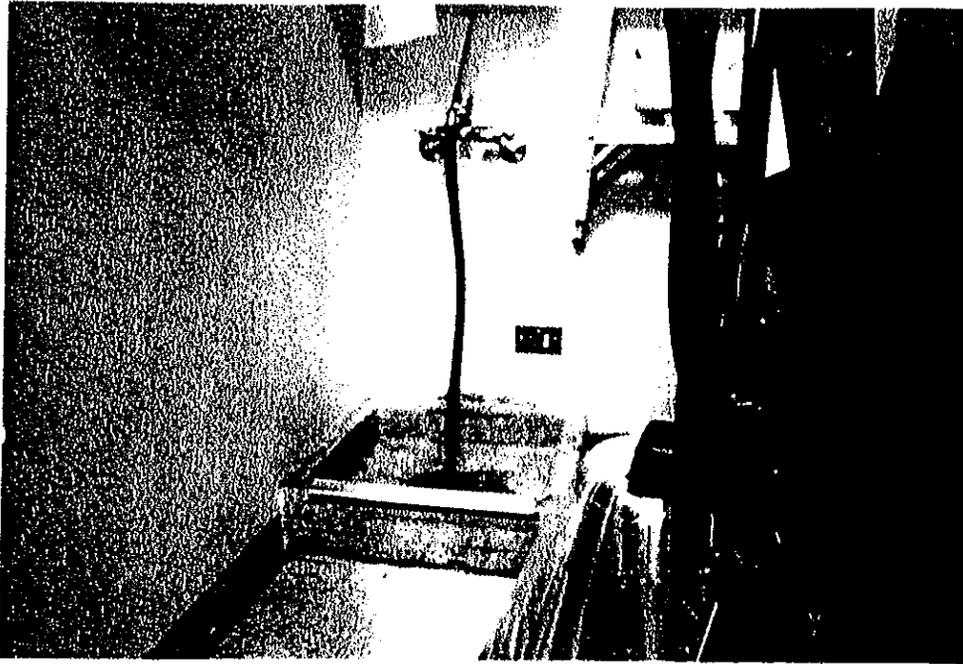
33 Janitors closet sink. Note hose on spigot and deteriorating wall behind.

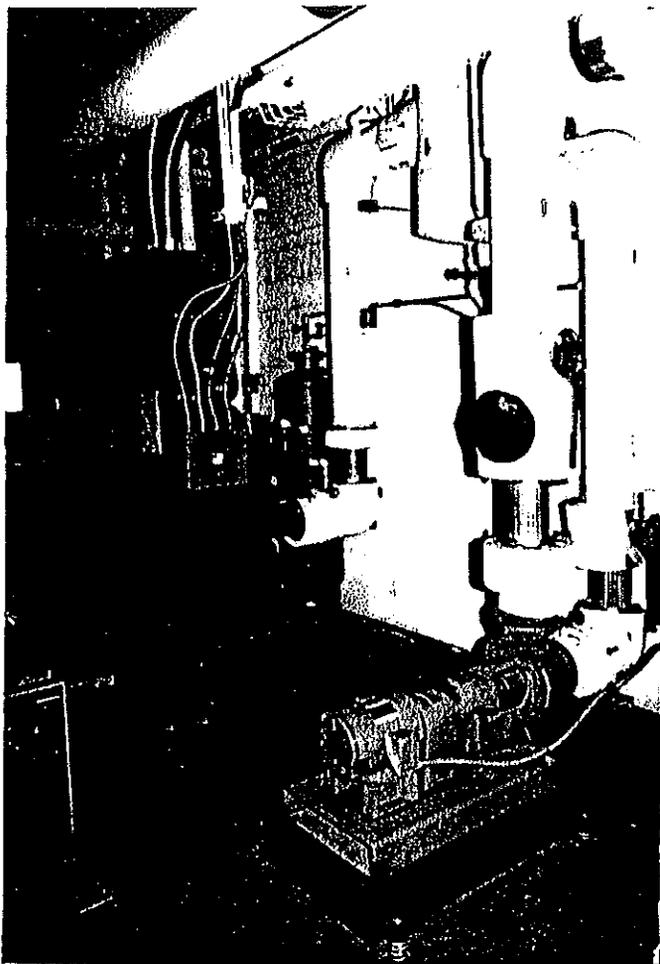
35 Chiller, pump, and air tank.
Note lack of housekeeping pads on
tank and pump.

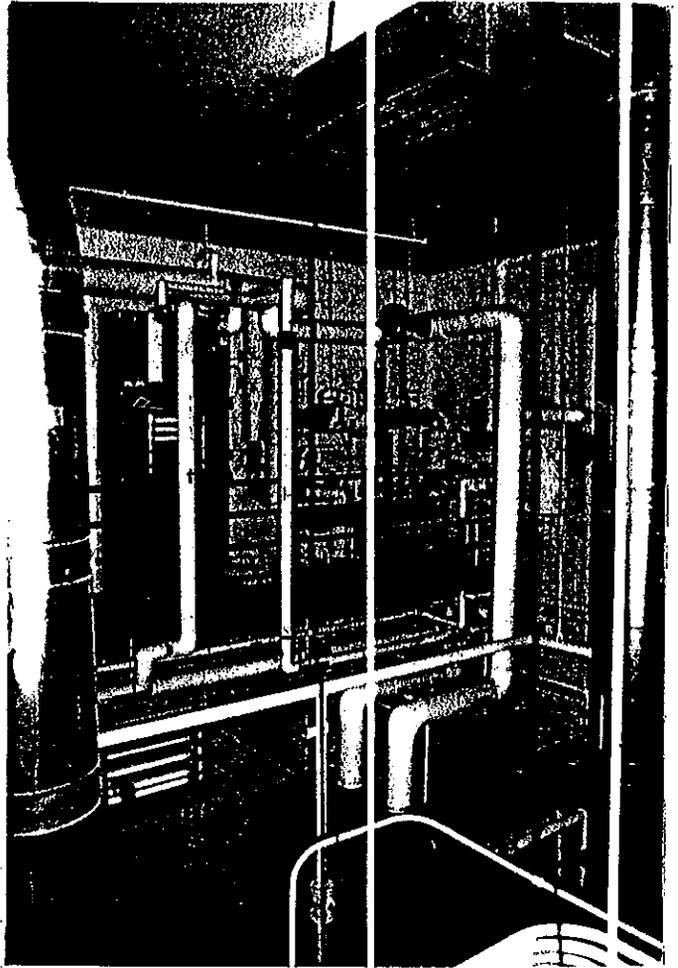
37 Boiler room ventilating system.
Note louver thru roof and two thru
wall, also lack of pipe hangers.

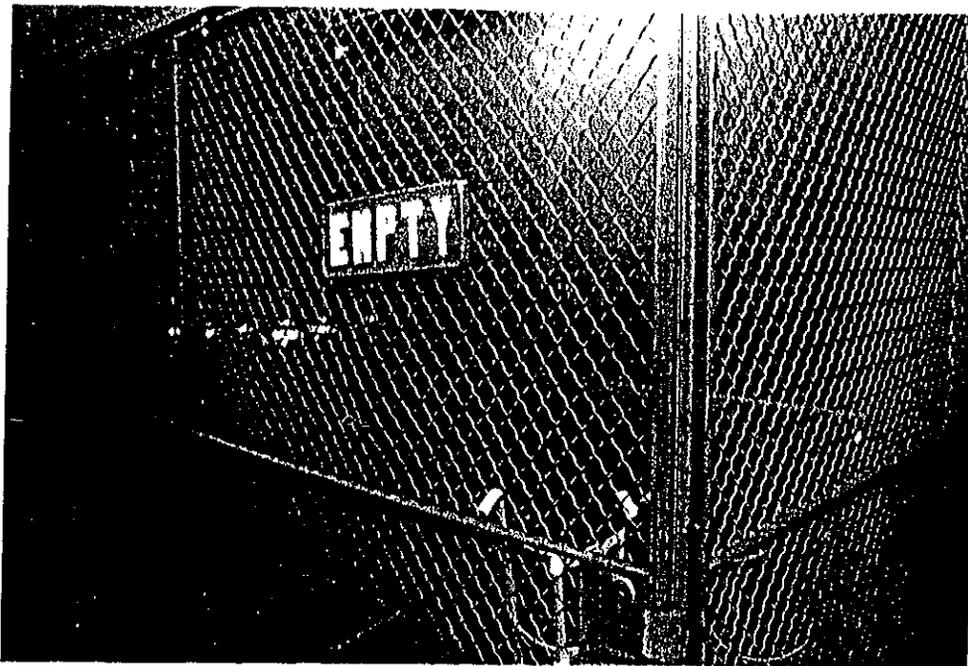
39 Caged empty gas cylinders not contained by chains.

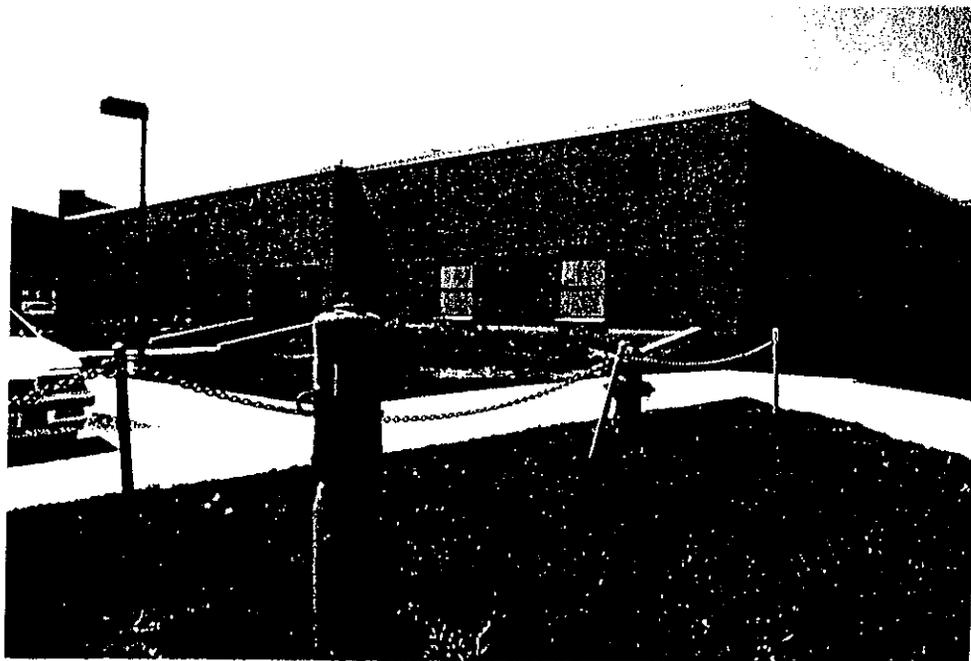
The post indicator valve is located adjacent to the heliport and appears to be installed on the new 6 inch diameter water pipe approximately 200 feet away, not within sight of the siamese connection location. Sheet No. M-10 indicates that there is to be a siamese connection installed on the building wall outside the north corner of the boiler room.

40 Post indicator valve (PIV) note facing of adjacent hydrant and lack of wrench on PIV.

Notice that the handle to operate the post indicator valve is missing (see photo 40). Photo 41 shows the fire department connection is not a siamese. Photo 37 shows the closest fire hydrant (at left in middle of picture) to the hose connection location (right wall in corner of building). NFPA 13, Section 2.7.2, requires the fire department connection to be siamese if the supply pipe is 4 inch nominal diameter, which it is, according to the plans.
