ALASKA NATIVE MEDICAL CENTER
ANCHORAGE, ALASKA

POST OCCUPANCY EVALUATION

Office of Environmental Health and Engineering
Office of Public Health
Indian Health Service

July 2002

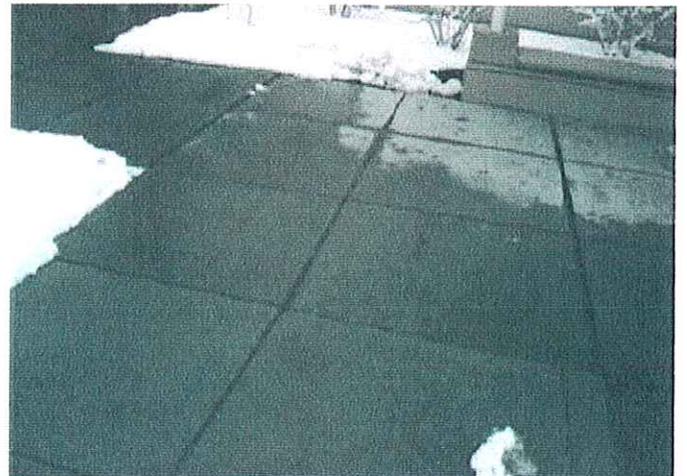
The heated sidewalks are effective keeping snow and ice from forming on the heated sections. A problem developed at the junction with the unheated sections (photo ANMC-4). As the ground froze the unheated sections rose up several inches and became a tripping hazard. This was corrected by tying the sections together with reinforcing steel. Because of the costs of heating the sidewalks, snow removal is accomplished manually.

ANMC-4 Freezing Walkway

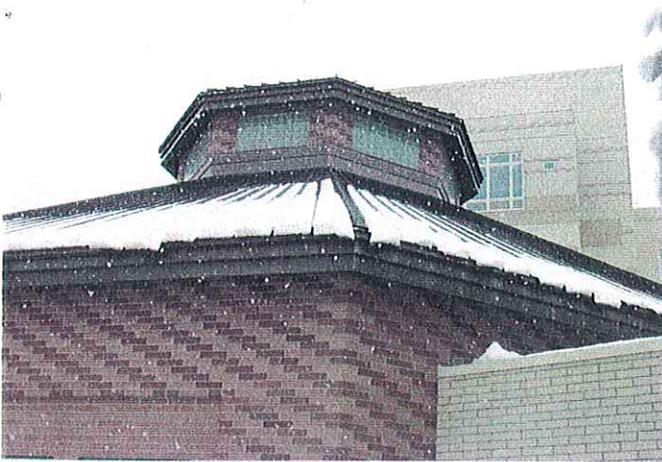
second system is a membrane roof system used on the flat roofs. It consists of concrete pavers (ballast) on a filter fabric, over 2 layers of rigid insulation board, on top of a single-ply roofing membrane, on tapered rigid insulation board, over roof substrate board. Some of the Tern coating on the stainless steel roofing has been staining and is being reviewed by the roofing supplier and installer (photo ANMC-7).

ANMC-7 Metal Roofing on Entrance Pod

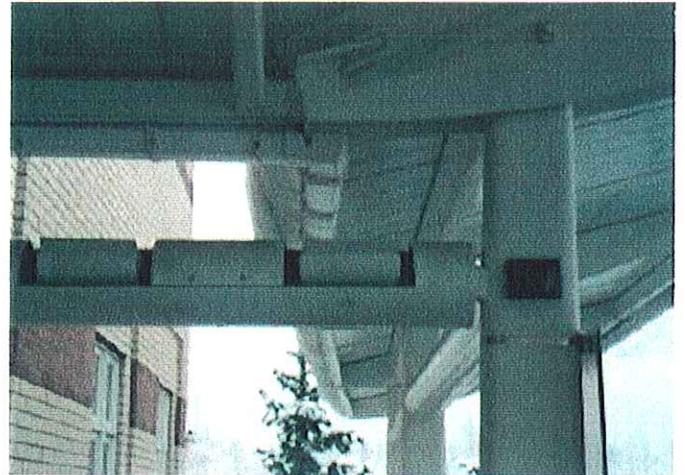
- (3) The overhead sidewalk canopies work well for the use intended in the Anchorage climate, however in periods where melting occurs the water drains directly on the uprights causing bulb and circuit failure. The design detail needs some alteration to avoid this problem that is being worked on by the Project Manager's office.

ANMC-8 Canopy with Lights

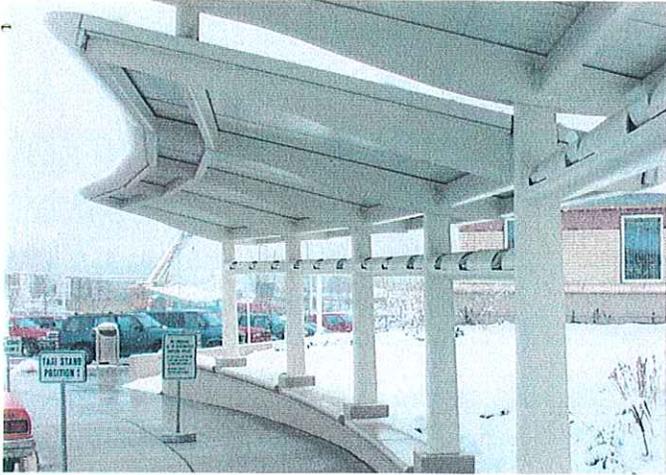
ANMC-19 Outside Smoking Area Under Canopy

Hostel where the exit doors emptied onto a concrete pad with no walkway leading away from the structure (photo-ANMC-18). This is a safety code violation and there are plans for a project to correct this. The sidewalks, especially under canopied areas near exits, are used extensively by smokers since smoking is prohibited in the ANMC. Designated smoking areas have been set up trying to balance the needs of smokers and non-smokers under the overhead canopies (photo ANMC-19).

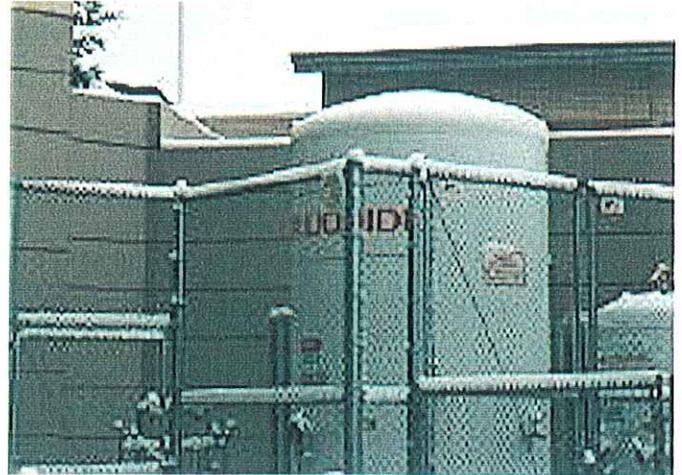
1. There is a problem with several retaining walls that exceed a four ft height (photo ANMC-20). They are readily accessible for children to play on and climb and are a potential falling hazard. This condition should be avoided in design or be topped with a non-climbable fence.

ANMC-20 Unfenced Retaining Wall Behind Tank

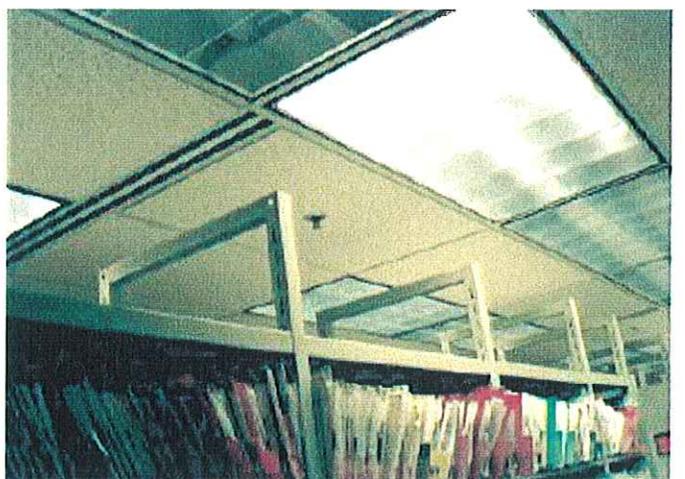
ANMC-24 Shelving Conflict with Sprinklers

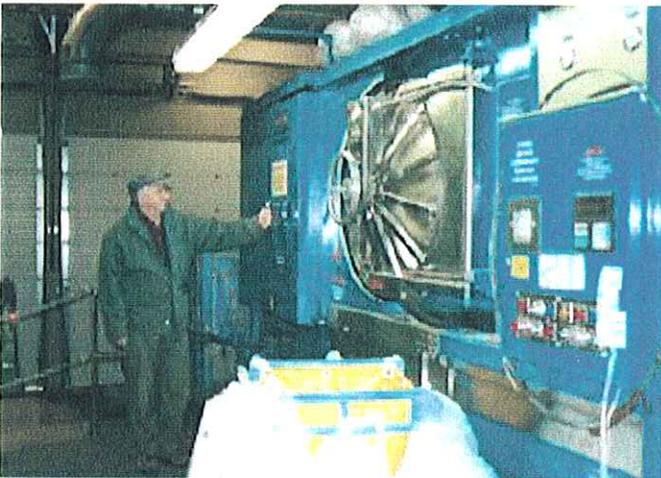
A San-I-Pak unit was installed to treat infectious wastes so that it can be handled by the solid wastes contractor as routine solid wastes. This unit autoclaves and compacts the infectious wastes and converts it to routine solid wastes. The climatic conditions in the winter required that an enclosure be built for the unit so that it would operate efficiently in the winter (photo ANMC-15).

ANMC-15 Sani-Pak Unit at Loading Dock

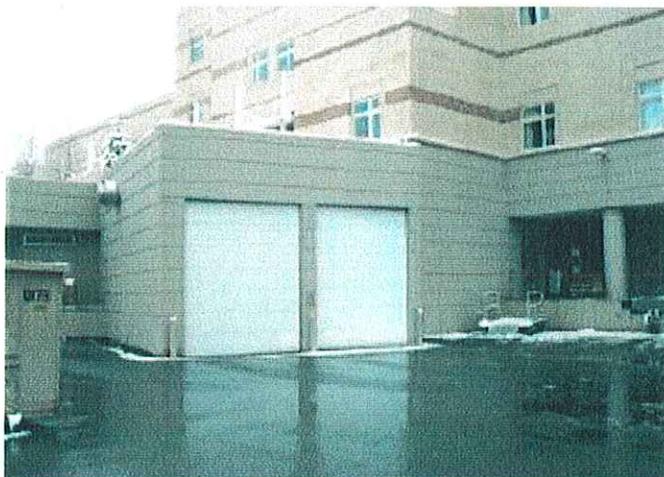
ANMC-17 Adjustable Loading Dock Bay (right)

The adjustable ramp for the smaller trucks is an important item and should be included for all health facilities with a loading dock (photo ANMC-3). The area is very tight when more than one large 18-wheeler delivery truck is unloading at the docking space. It is recommended that design turning radii for vehicles substantially greater than the minimum be used or design solutions be considered that depend less on the turning radius. There are several other items that should be considered for future receiving and loading dock areas. Provide staging area inside the building adjacent to the dock that would allow efficient handling of large deliveries avoiding excessive handling, breaking down large pallet loads and temporary storage. The NO2 storage room, which is adjacent to the dock, has a ceiling height in greater than 18ft. This is excessive and causes internal temperature control problems during the winter due to stratification.

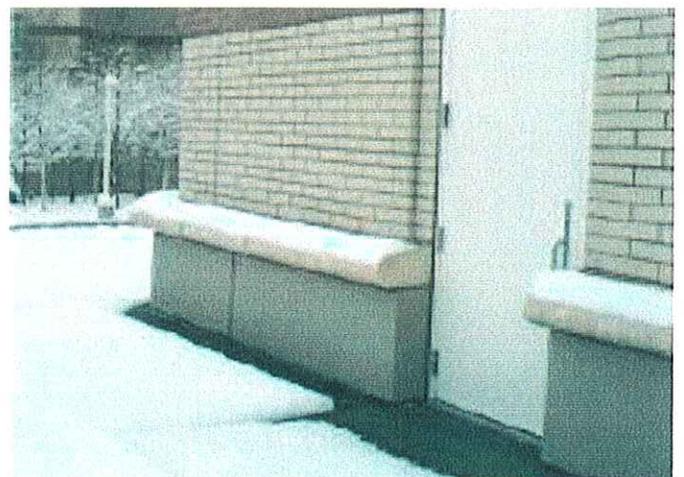
The existing west exits of the two Hostel wings discharge to a grass-covered sloped landscaped area, with no easily found route to the adjacent sidewalk (photo ANMC-18).

ANMC-18 Hostel Exit with no Walkway
