**INDIAN HEALTH SERVICE HOSPITAL  
PINE RIDGE, SOUTH DAKOTA**

**POST OCCUPANCY EVALUATION**

**February 1997**

**ENVIRONMENTAL HEALTH AND ENGINEERING  
INDIAN HEALTH SERVICE**

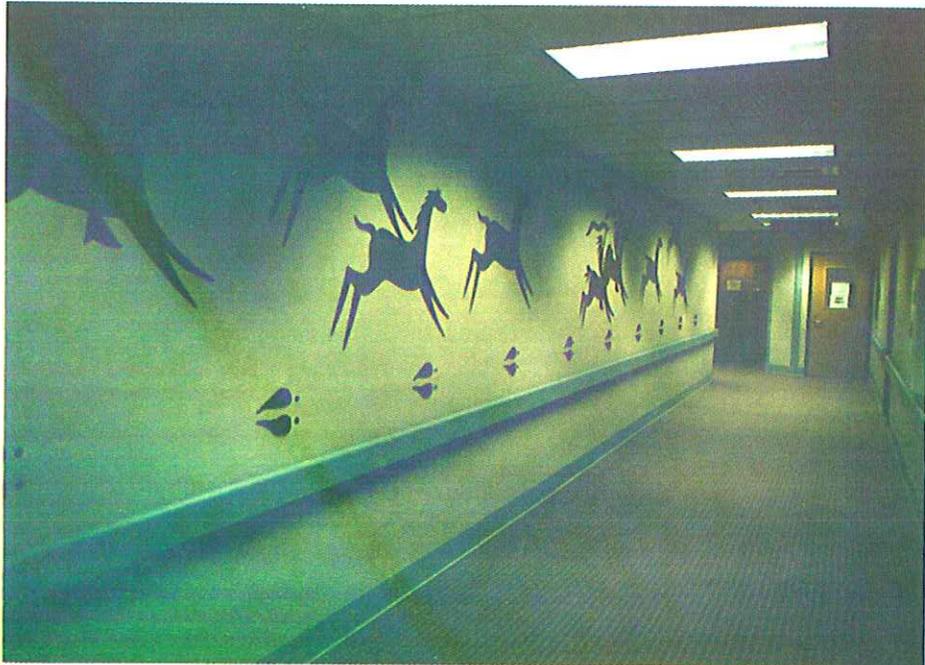
(A-10) Corridor With Graphic Design

- (2) **Corridor Guardrails:** The combination guardrails/handrails installed in most public corridors help to protect wall surfaces from damage (see photo A-10). This is a good feature. Rails are fabricated of molded plastic over a steel backing plate. The plastic occasionally fractures under the impact of carts, but it is easily replaced.

- (4) **Wall Protection:** Combination guardrails/handrails installed in most public corridors have done much to protect wall surfaces from damage (see photo A-10). They are made of molded plastic with a textured finish.

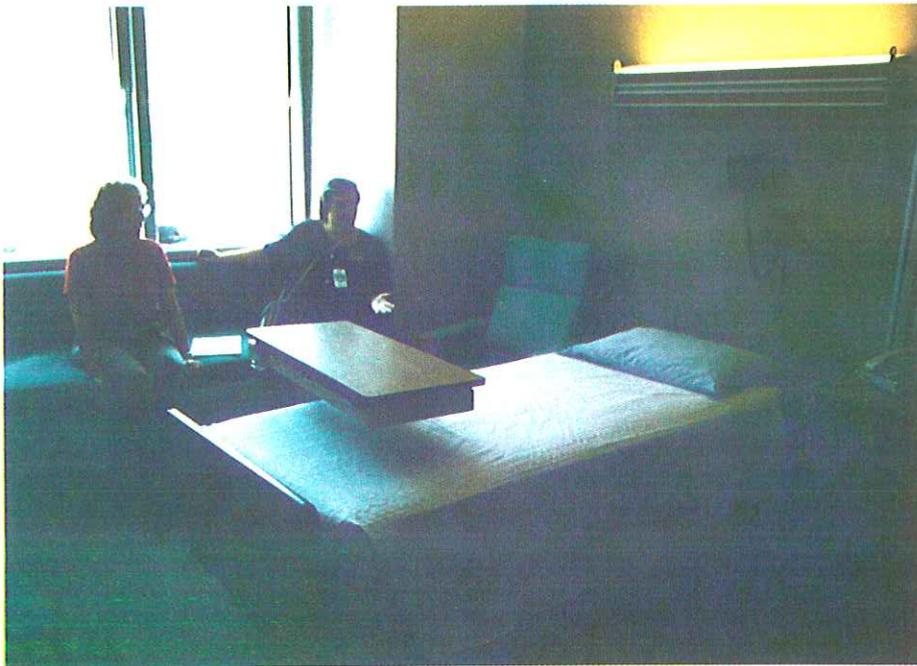
(A-13) Typical Patient  
Toilet With Shower Stall

- (1) **Handicapped Accessibility:** Spaces intended for public and staff use are generally accessible to the physically disabled. However, one deficiency noted was the 100 mm curb at the shower in the typical patient room (see photo A-13 and Section 9, 11.0 ACUTE CARE NURSING). Patient toilet doors have raised marble thresholds, which are a tripping hazard for both able-bodied and handicapped. Also, the audiology testing booth in Ambulatory Care is not wheelchair accessible.

- All patient room toilets include shower stalls with standard 100 mm tiled curbs (see photo A-13). This makes access by mobility impaired persons difficult and wheelchair access impossible. Toilet entrances have raised marble thresholds at doors, which may meet codes, but are tripping hazards for both able-bodied and handicapped.

- (1) Implement the cart exchange supply distribution and management system to utilize storage space more efficiently.
- (2) Install curbless showers in 10% of patient rooms to comply with accessibility standards. (Because these showers often spill water into the adjacent space, their general use throughout a facility is not recommended.)
- (3) Install guardrails/handrails in corridors to protect wall surfaces from damage. This hospital is a good example of their use.
- (4) Use keyed locks to limit opening of operable windows and, therefore, reduce dust and insect penetration.

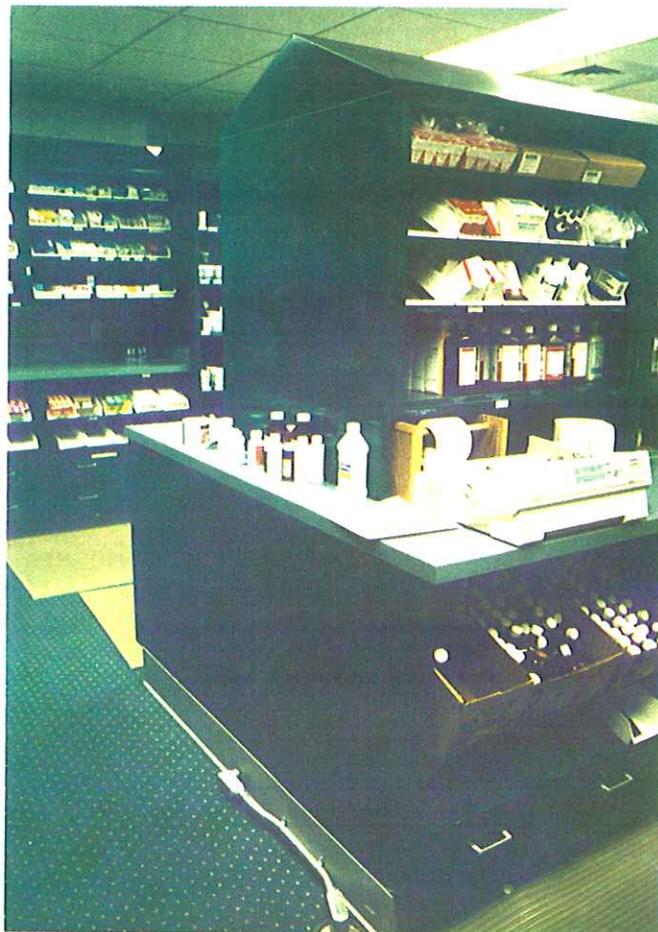
(A-21) Pharmacy Center  
Island with Exposed  
Electrical Conduit

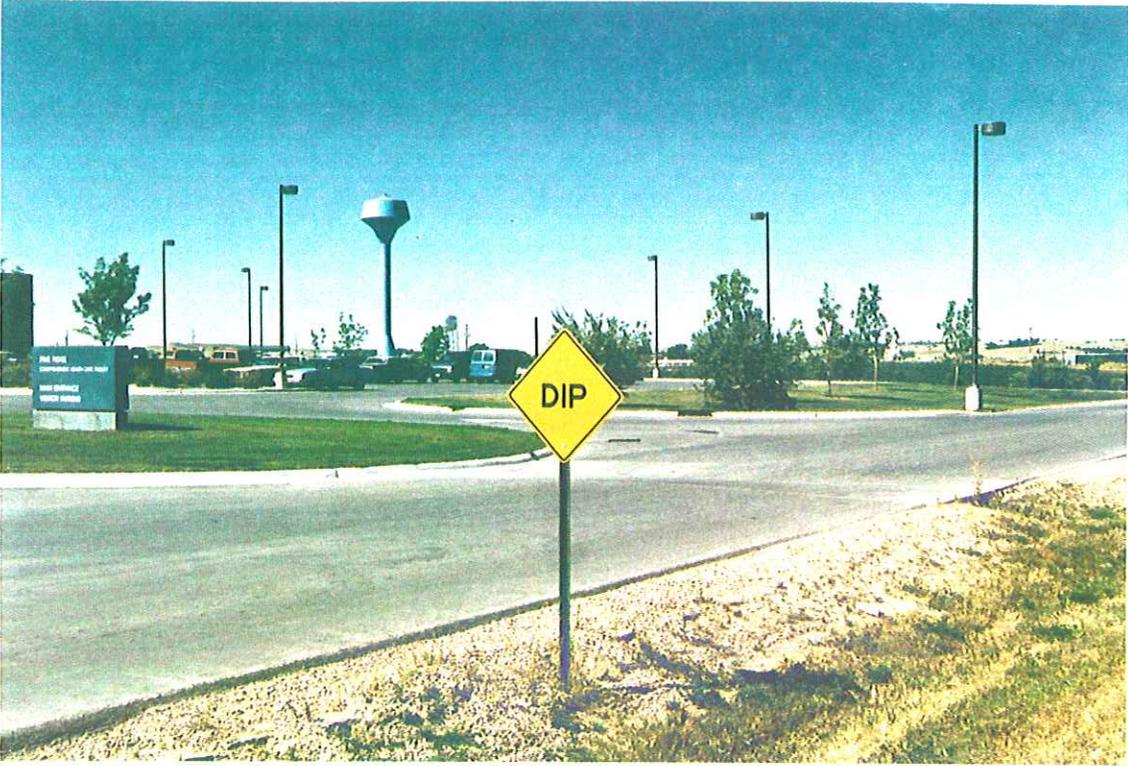
(CS-5) Loop Road Pavement Failure

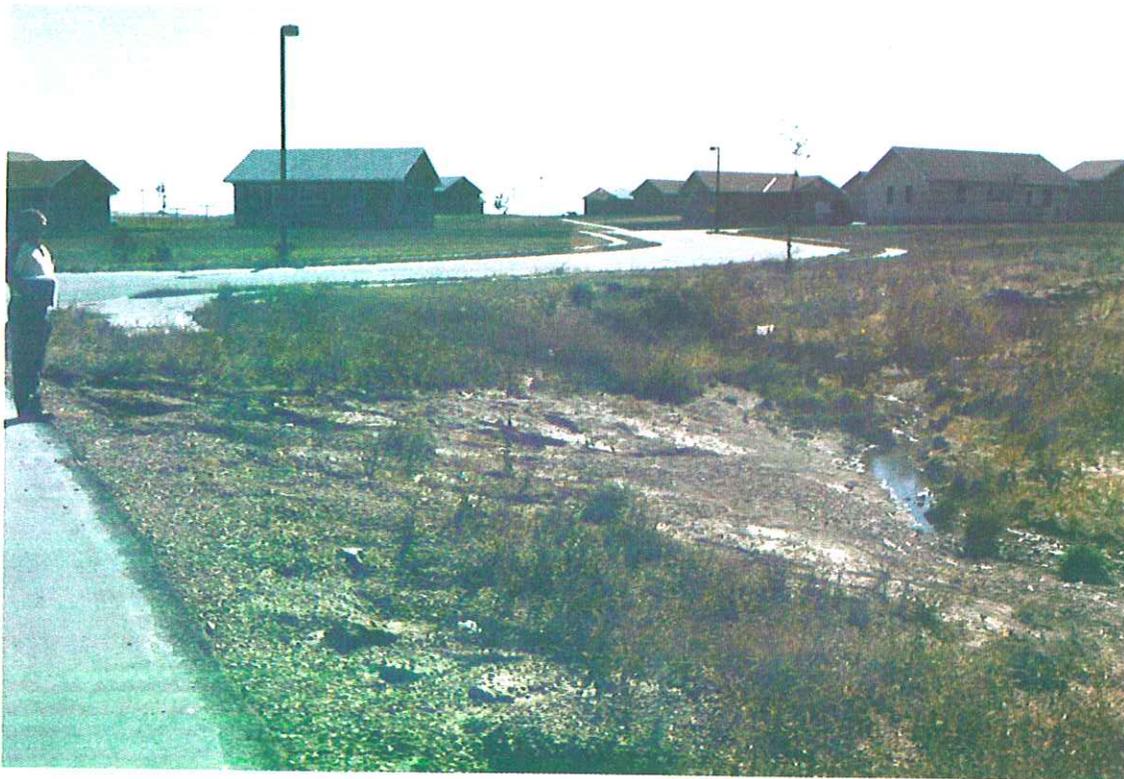
(CS-8) Erosion at Intersection of the Loop and "D" Road

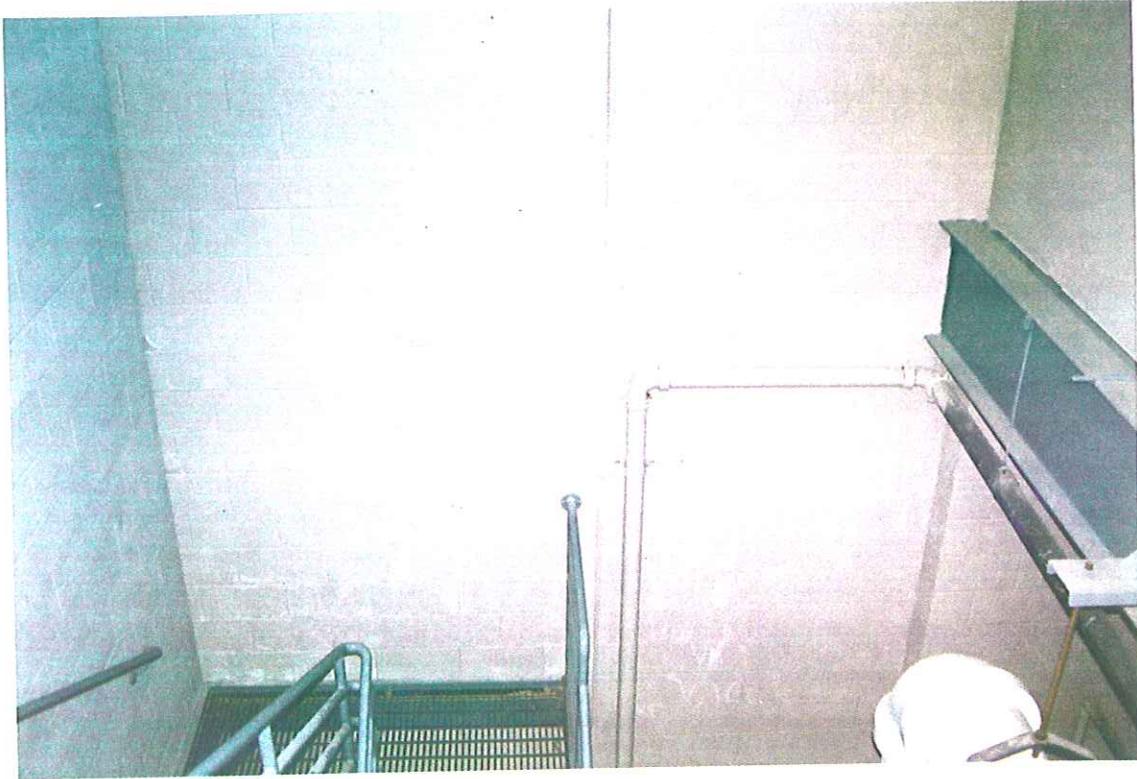
(CS-9) Mechanical Room-North Wall

1. There is a waterproofing problem at the north wall of the mechanical equipment room (photo CS-9). Evidently the paint is showing efflorescence from excess moisture in the wall.
2. Parapet flashing shows signs of separation (photo CS-10). It is speculated that some pieces of flashing are not anchored correctly, and that this causes the separation.
3. On the north side of the loop roadway there is a settlement failure. Evidently, environmental conditions have caused settlement around a drainage pipe under the road (photo CS-5). Correction of the problem would require major repairs to the drainage system and the roadway surface.

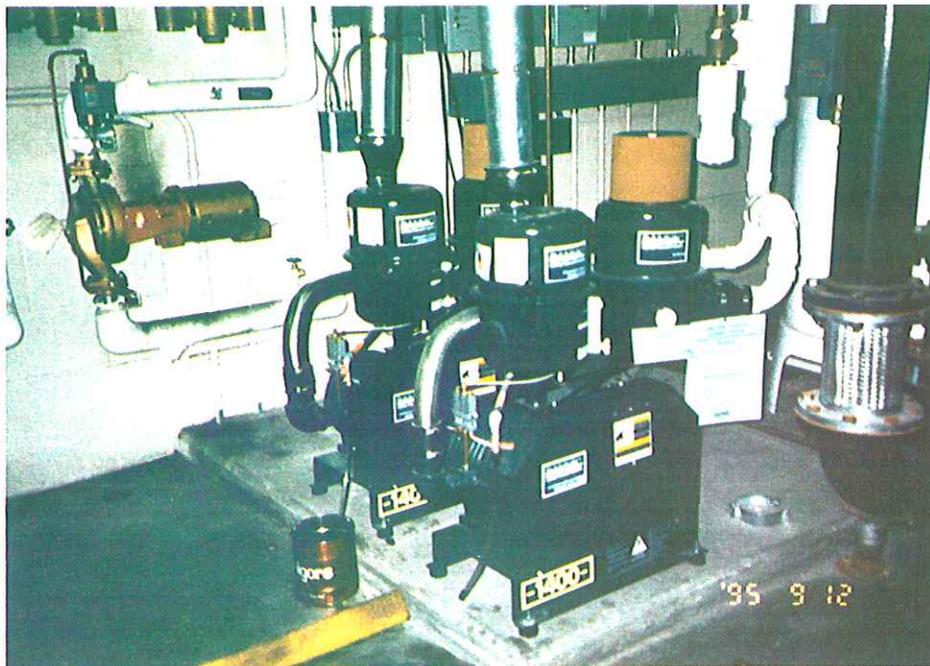
(M-9) New Dental Vacuum Equipment

Dental vacuum suction was inadequate. Dental turbine was replaced with RamVac dental vacuum unit.

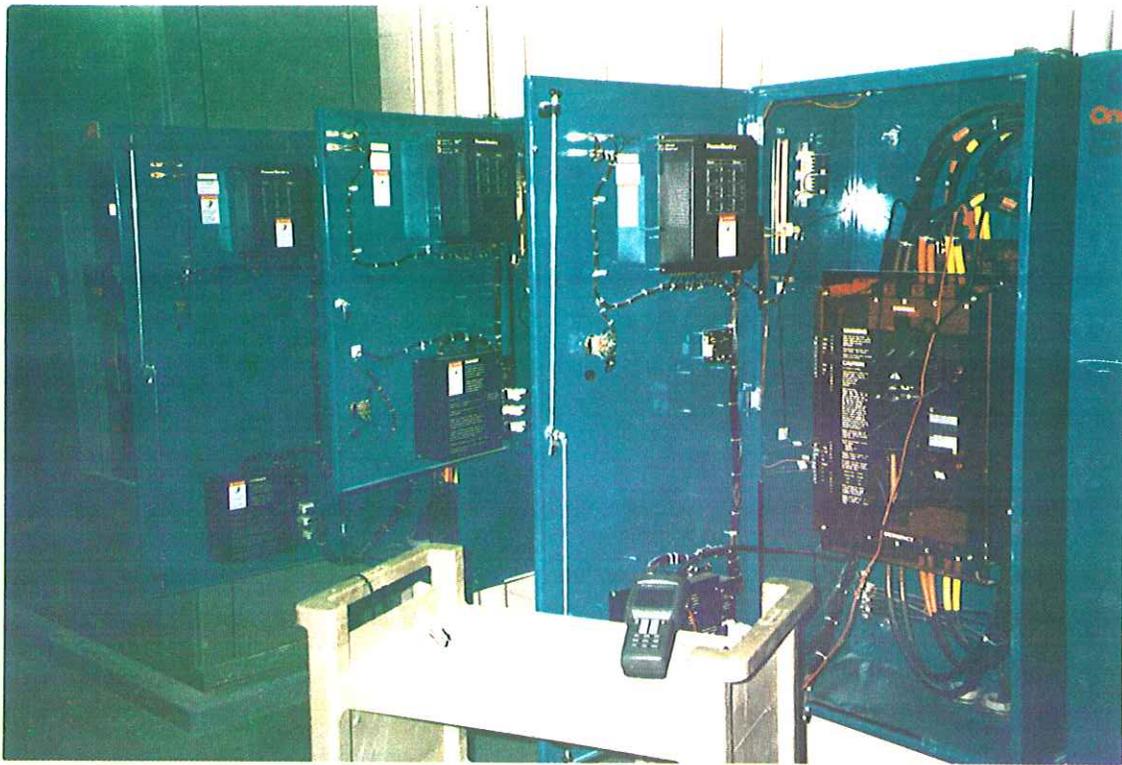
(E-3) Electric Power Field Test Points

Field testing (photo E-3) indicates that the areas where post hospital completion installation of equipment and system furniture (photos E-4, E-5 and E-6) are areas with excessive current on the branch circuit neutral conductors. The areas of concern are the administrative and outpatient areas of the hospital. There are indications of some equipment malfunction and possible fire hazard. The graphs from the field tests (APPENDIX II) indicates a problem since the form of the current wave is not smooth.
